SIERRITA MINE TAILINGS DISCLOSURE REPORT

SEPTEMBER 2024

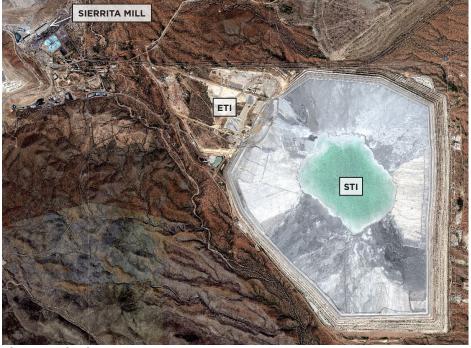
Figure 3. Sierrita Layout (June 2024).

The STI is located approximately 0.8 kilometers west of the westernmost extent of Green Valley, Arizona, approximately 6.3 kilometers southeast of the mill site and immediately and east of the ETI. The STI is contiguous with the inactive ETI that forms the northwest edge of the facility, as shown on Figure 3. Tailings deposition at STI was initiated in 1970 and continues to date. Deposition has raised the embankment so that both abutments are now in contact with the ETI. An embankment, called the ETI/STI Tie-In, is constructed across a portion of the ETI. The STI is constructed using the header and spigot upstream construction method, while the ETI/STI Tie-In embankment is constructed using the centerline method. The STI is partially divided (by the central divider dike) into two deposition areas referred to as the North Dam and South Dam. Tailings deposition is alternated between the North and South Dams. Process water is collected by bargemounted pumps located near the middle of the reclaim pond and returned to the mill for reuse. Sierrita is on the eastern flank of the Sierrita Mountains in the Tucson Basin portion of the Basin and Range physiographic province. The impoundment is founded on a broad, gently sloping (approximately 2%) Quaternary and late Tertiary alluvial plain, which was deposited from streams emanating from the Sierrita Mountains, located approximately 8 kilometers to the west. The regional climate is characterized as arid steppe or arid desert by the Köppen-Geiger classification system. The average precipitation is approximately 34 centimeters. Precipitation occurs primarily during monsoon season from June 15th through September 30th with July typically being the wettest month of the year. The 30-year temperature is an average low of approximately 2 degrees Celsius (°C) in January and December to an average high of 37 °C in June. The annual average maximum temperature is approximately 27 °C (PRISM Climate group for 1991-2020). The calculated 10-year annual average potential evapotranspiration from 2014 to 2023 at both the Sahuarita AZMet station and the Tucson AZMet station is 180 centimeters. The seismic hazard is characterized as low to moderate even at the long return period of 10,000 years. The seismic hazard is controlled by background earthquakes at return periods up to 10,000 years and by the Santa Rita fault at longer return periods.
